# Red River Waterway, Lock and Dam No. 4

## Report 2

## Navigation Alignment Conditions

## Hydraulic Model Investigation

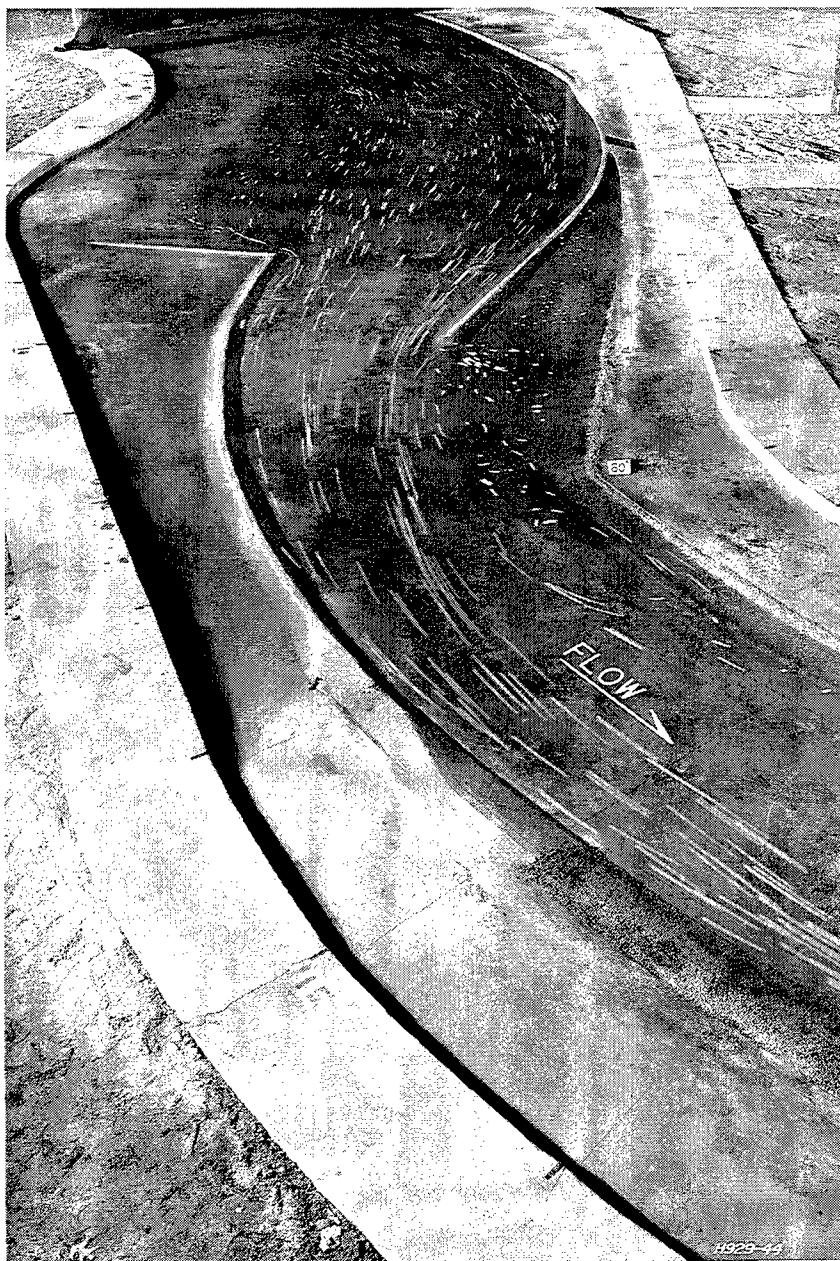
Photo 1. Plan B, looking upstream, discharge 60,000 cfs. Confetti showing surface current patterns entering and through Piermont cutoff

Current direction and velocity data, shown in Plates 1-5, indicate a concentration of flow through the constriction formed by the convergence of the stone-fill dikes at the upstream entrance to Piermont cutoff (Photo 1). The

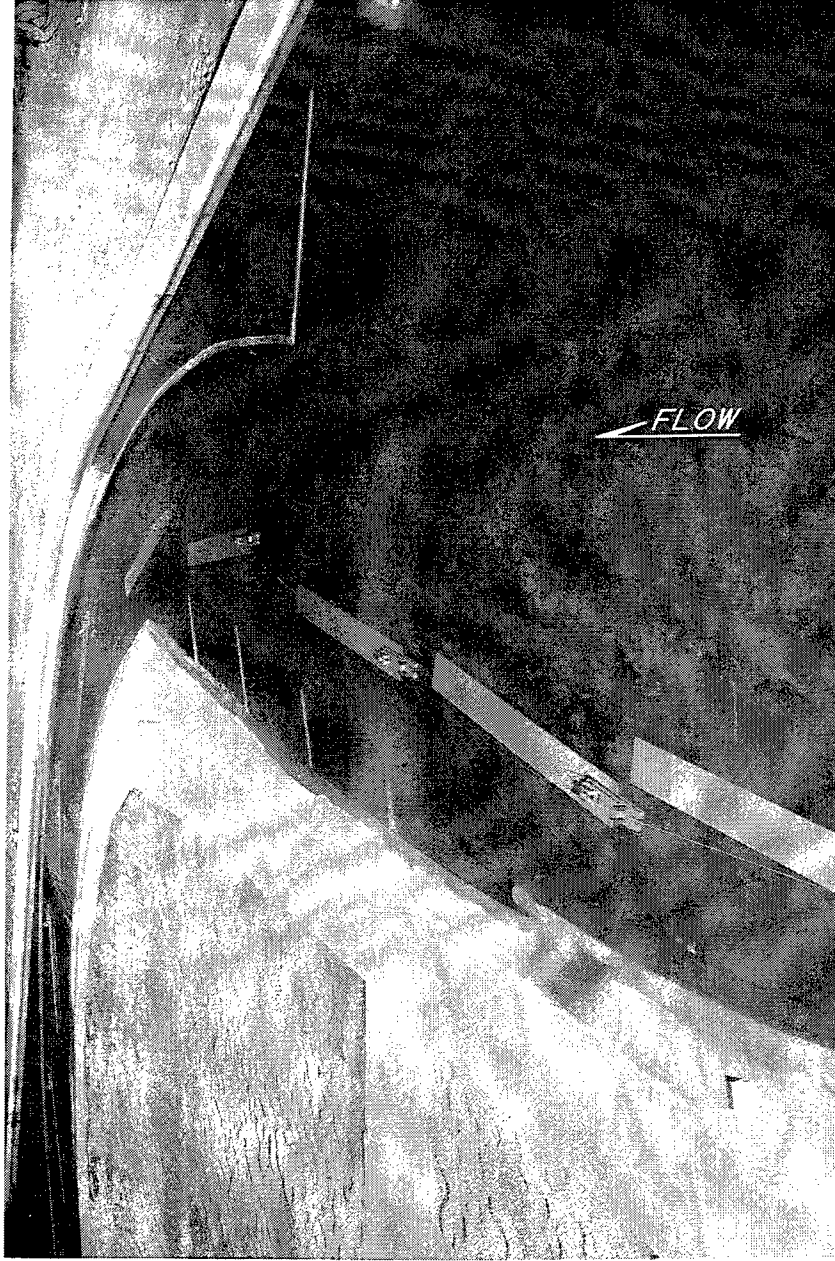
Photo 12. Plan C, looking downstream, discharge 60,000 cfs. Path of downbound tow driving past four spur dikes and into Piermont cutoff

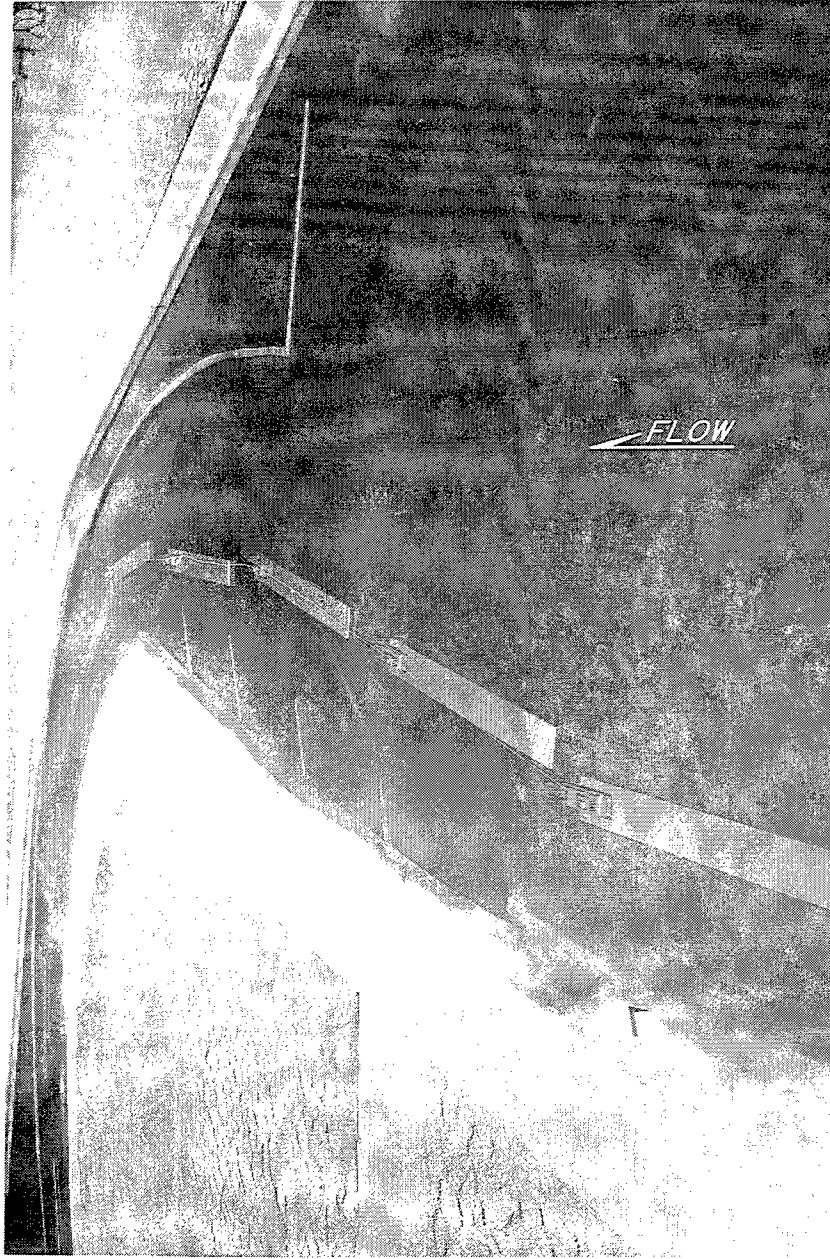
Photo 14. Plan C, looking downstream, discharge 80,000 cfs. Path of upbound tow leaving Piermont cutoff

Navigation conditions for upbound tows navigating Piermont cutoff were satisfactory with all riverflows. However, it should be noted that some maneuvering was required at the upstream entrance of the cutoff (Photo 14).

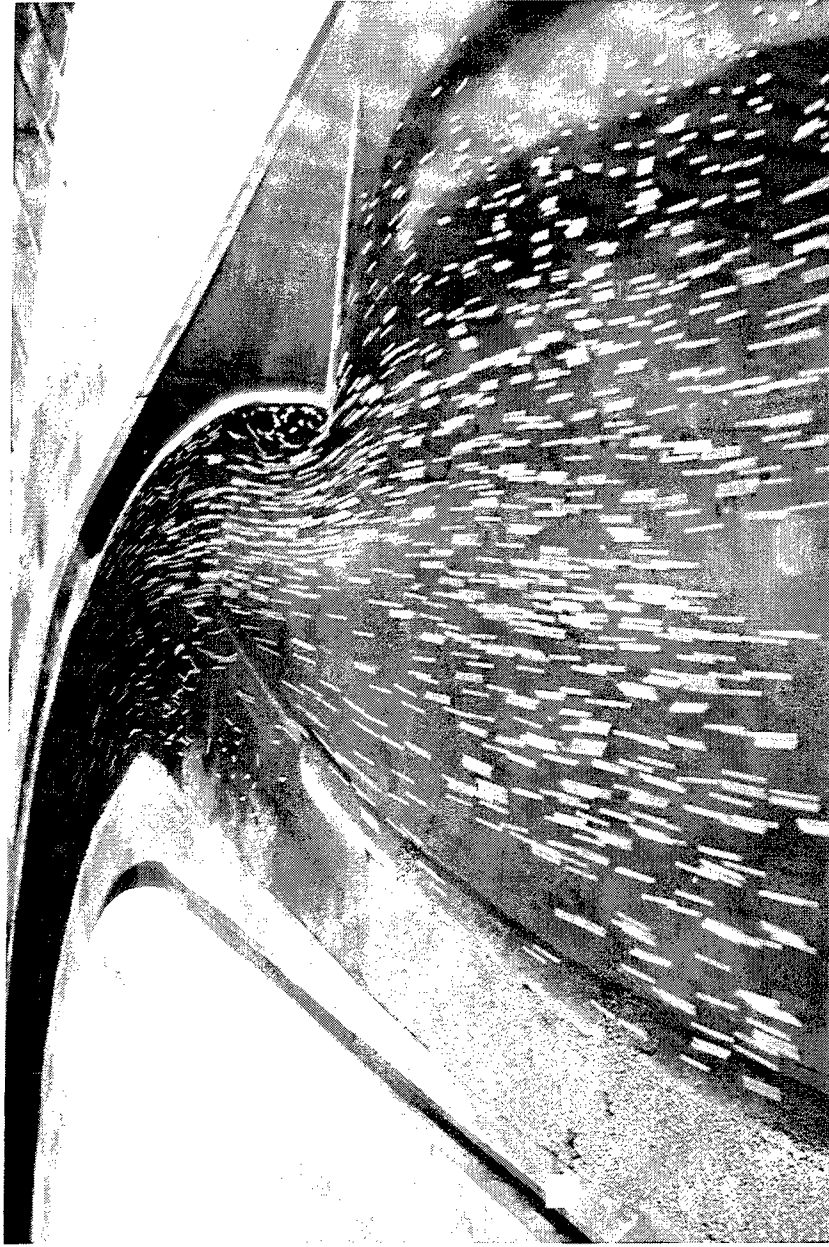
Photo 26. Plan D, looking downstream, discharge 80,000 cfs. Confetti showing surface current patterns
